**ELECTRONICS COORDINATING OF**  
**SHIP PREPARATION**  
**and**  
**TARGET INSPECTION**

**FINAL REPORT**  
**TESTS ABLE AND BAKER**

**VOLUME 2**  
**PHOTOGRAPHIC RECORD**

**DIRECTOR OF SHIP MATERIAL**  
**JOINT TASK FORCE ONE**  
**OPERATION CROSSROADS**

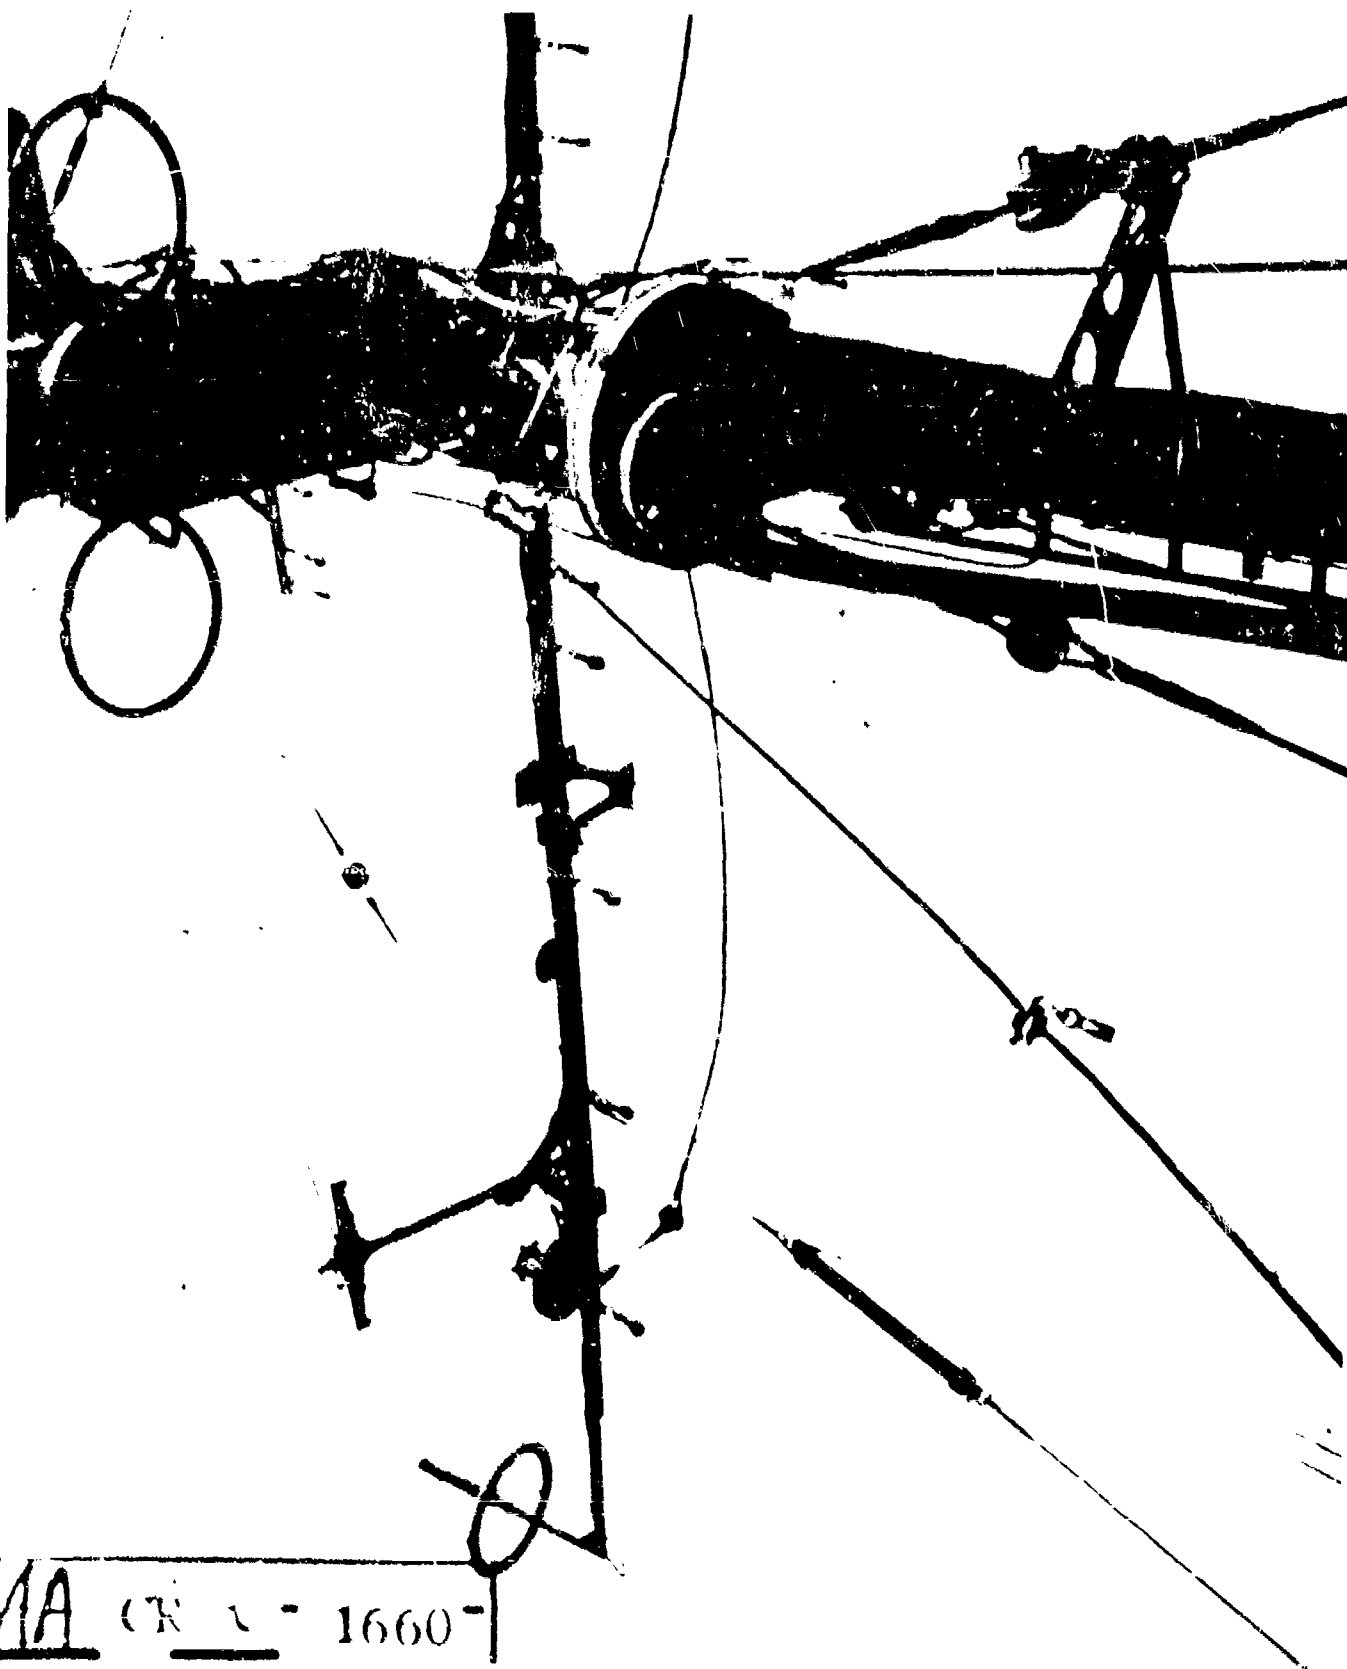
POST ABLE - COMMUNICATION ANTENNAS. The TBS antenna pedestal on starboard yardarm was bent forward about 90° by blast. No elements were damaged and antenna lead was intact. A bent whip antenna can also be seen on yardarm.

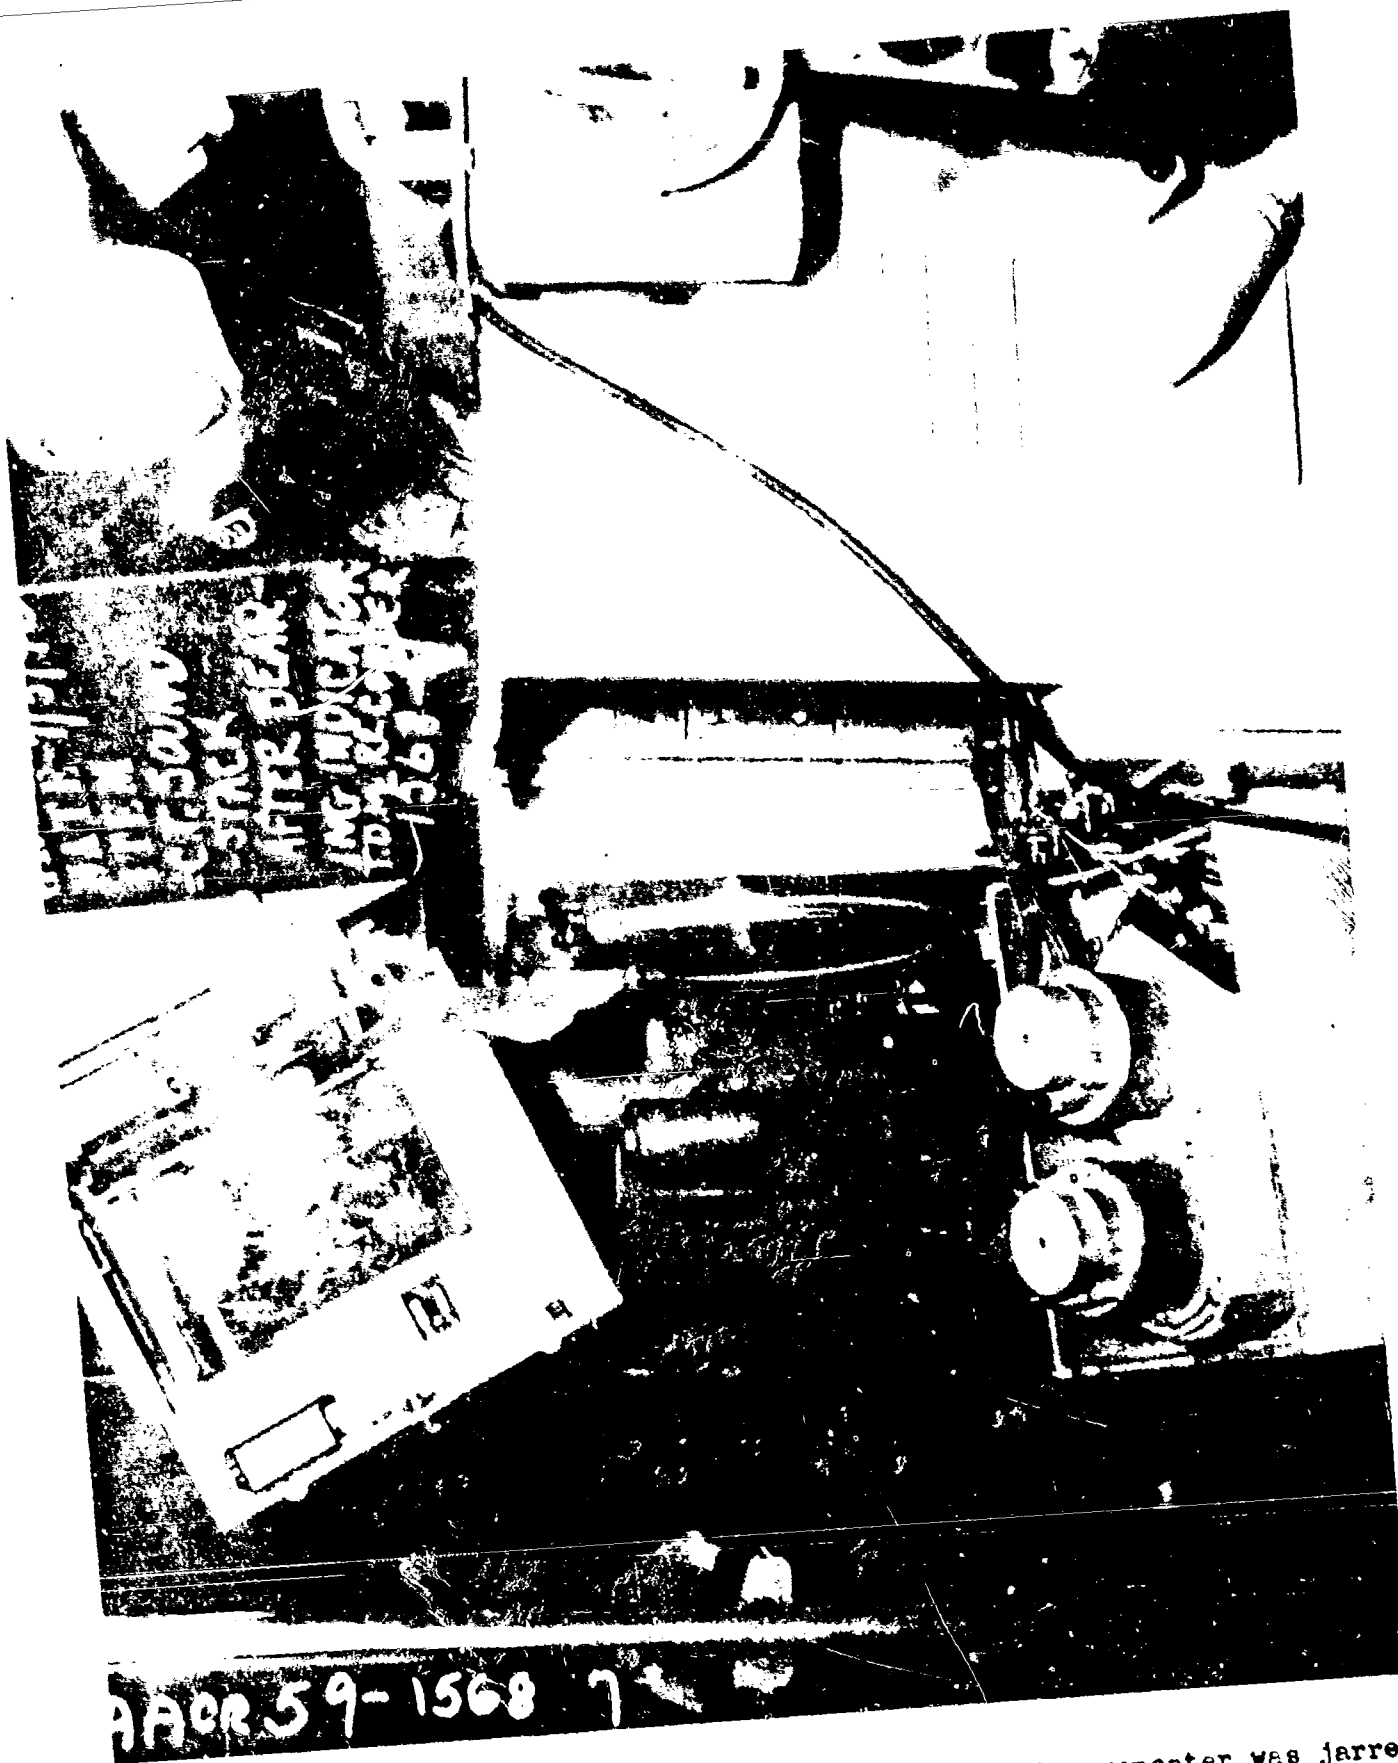
POST ABLE - WCA SOUND STACK. QB head bearing repeater was jarred out of its frame because of a loose pin in the securing brace. Front panel of the TDM recorder dropped open, releasing the roll holding the recording paper. Damage was not serious and operation was found to be satisfactory.

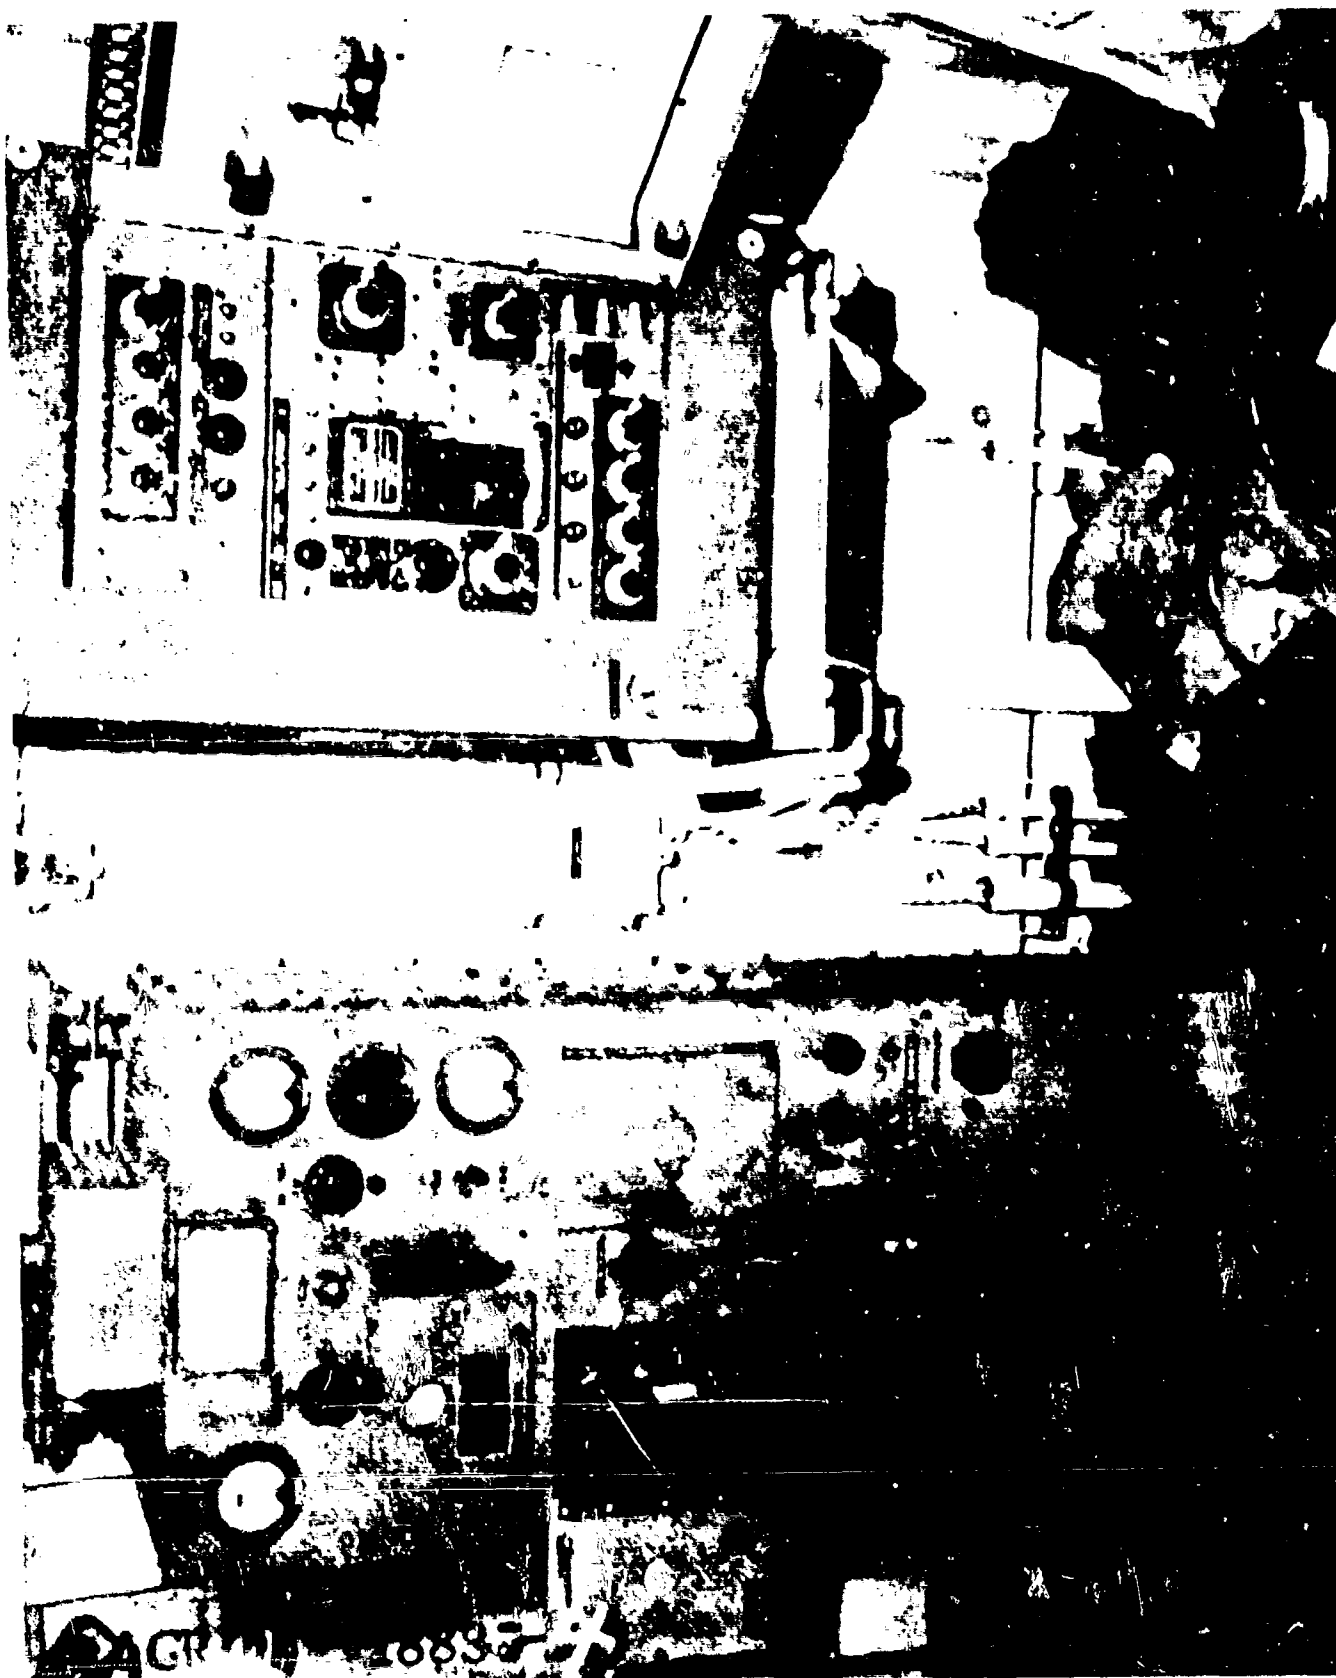
POST ABLE - SC-4 TRANSMITTER. Front view of the exposed transmitter showing damage to meters, knobs and access doors.

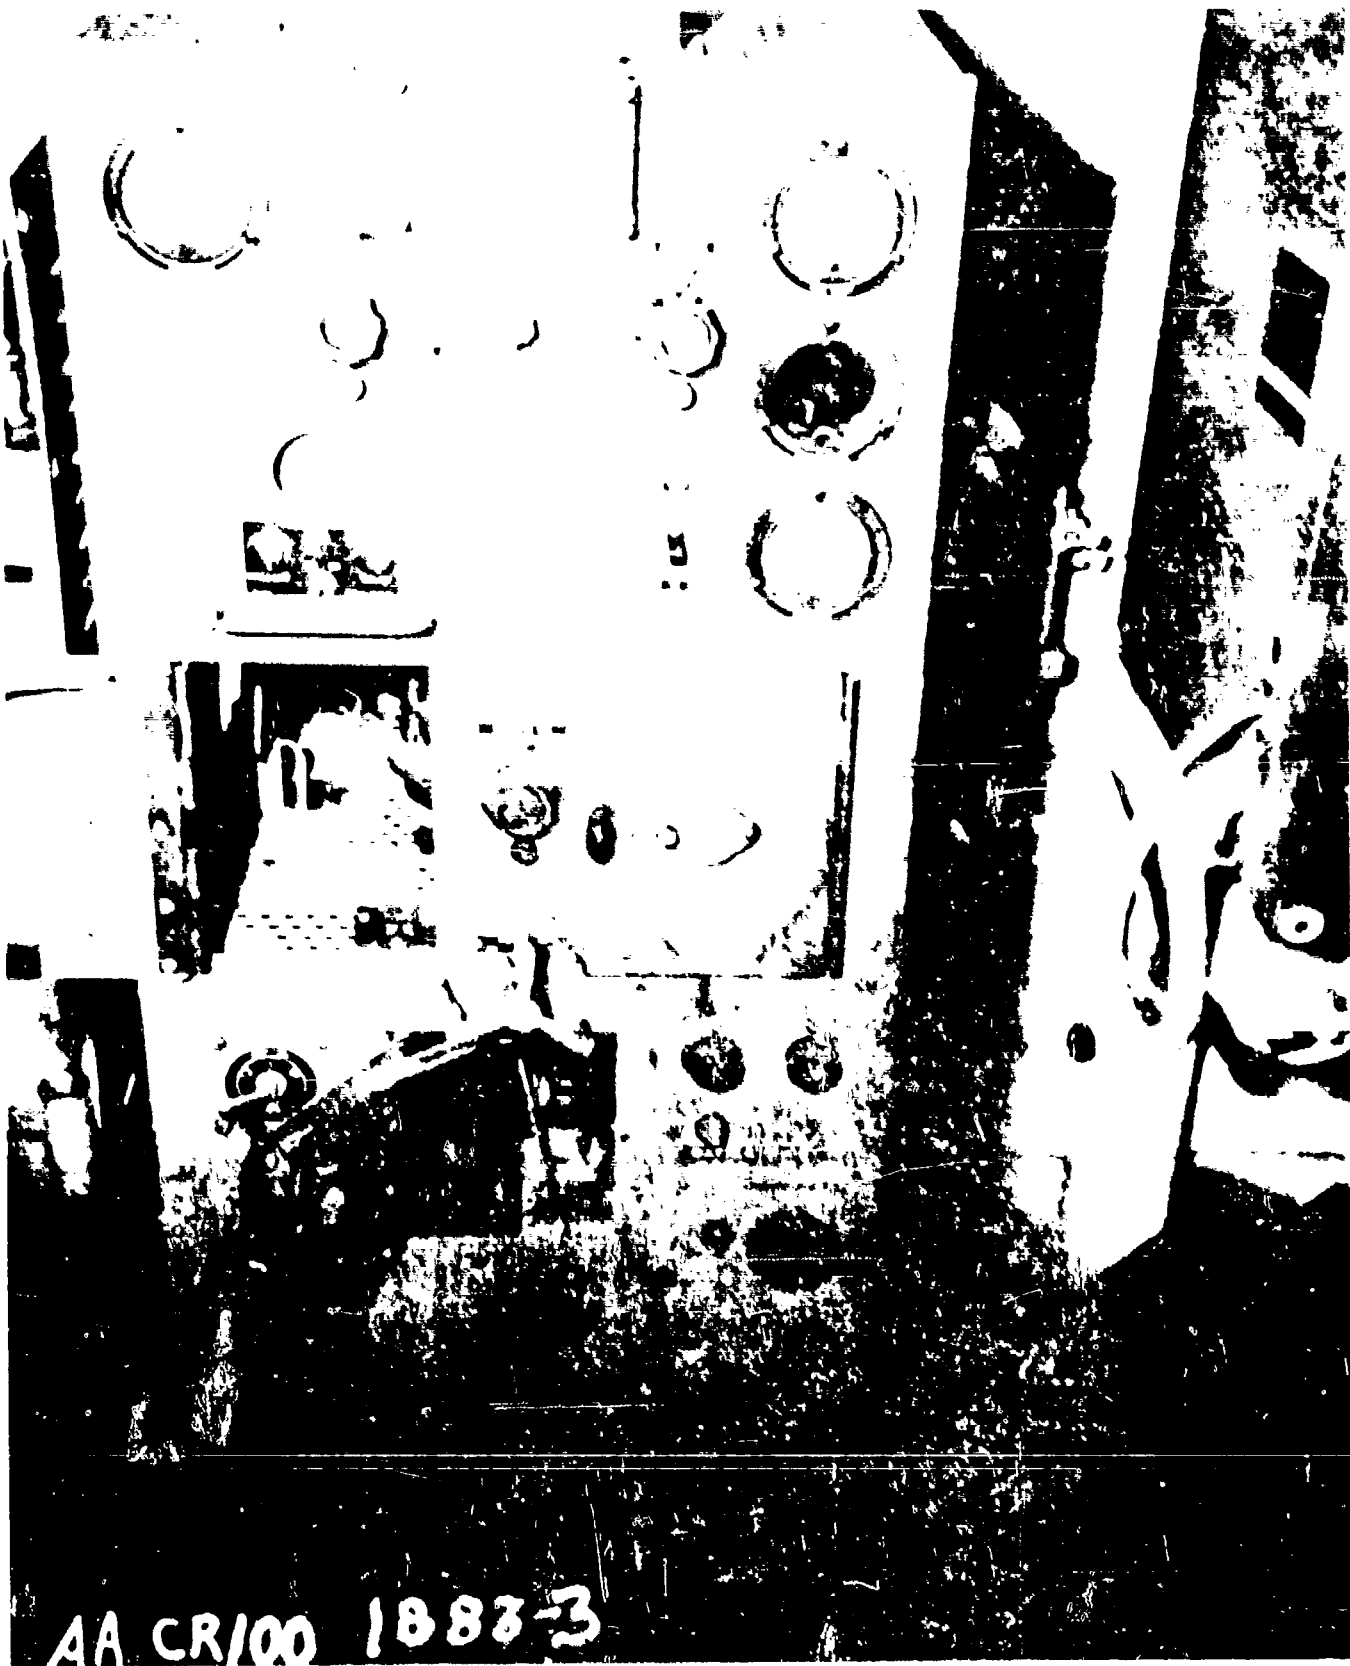
POST ABLE - SC-4 TRANSMITTER. Close-up view of the front of the SC-4 transmitter exposed to radiation. Plastic pilot light covers and knobs were seared, access doors bent, and meters damaged. The 327-A tubes were broken.

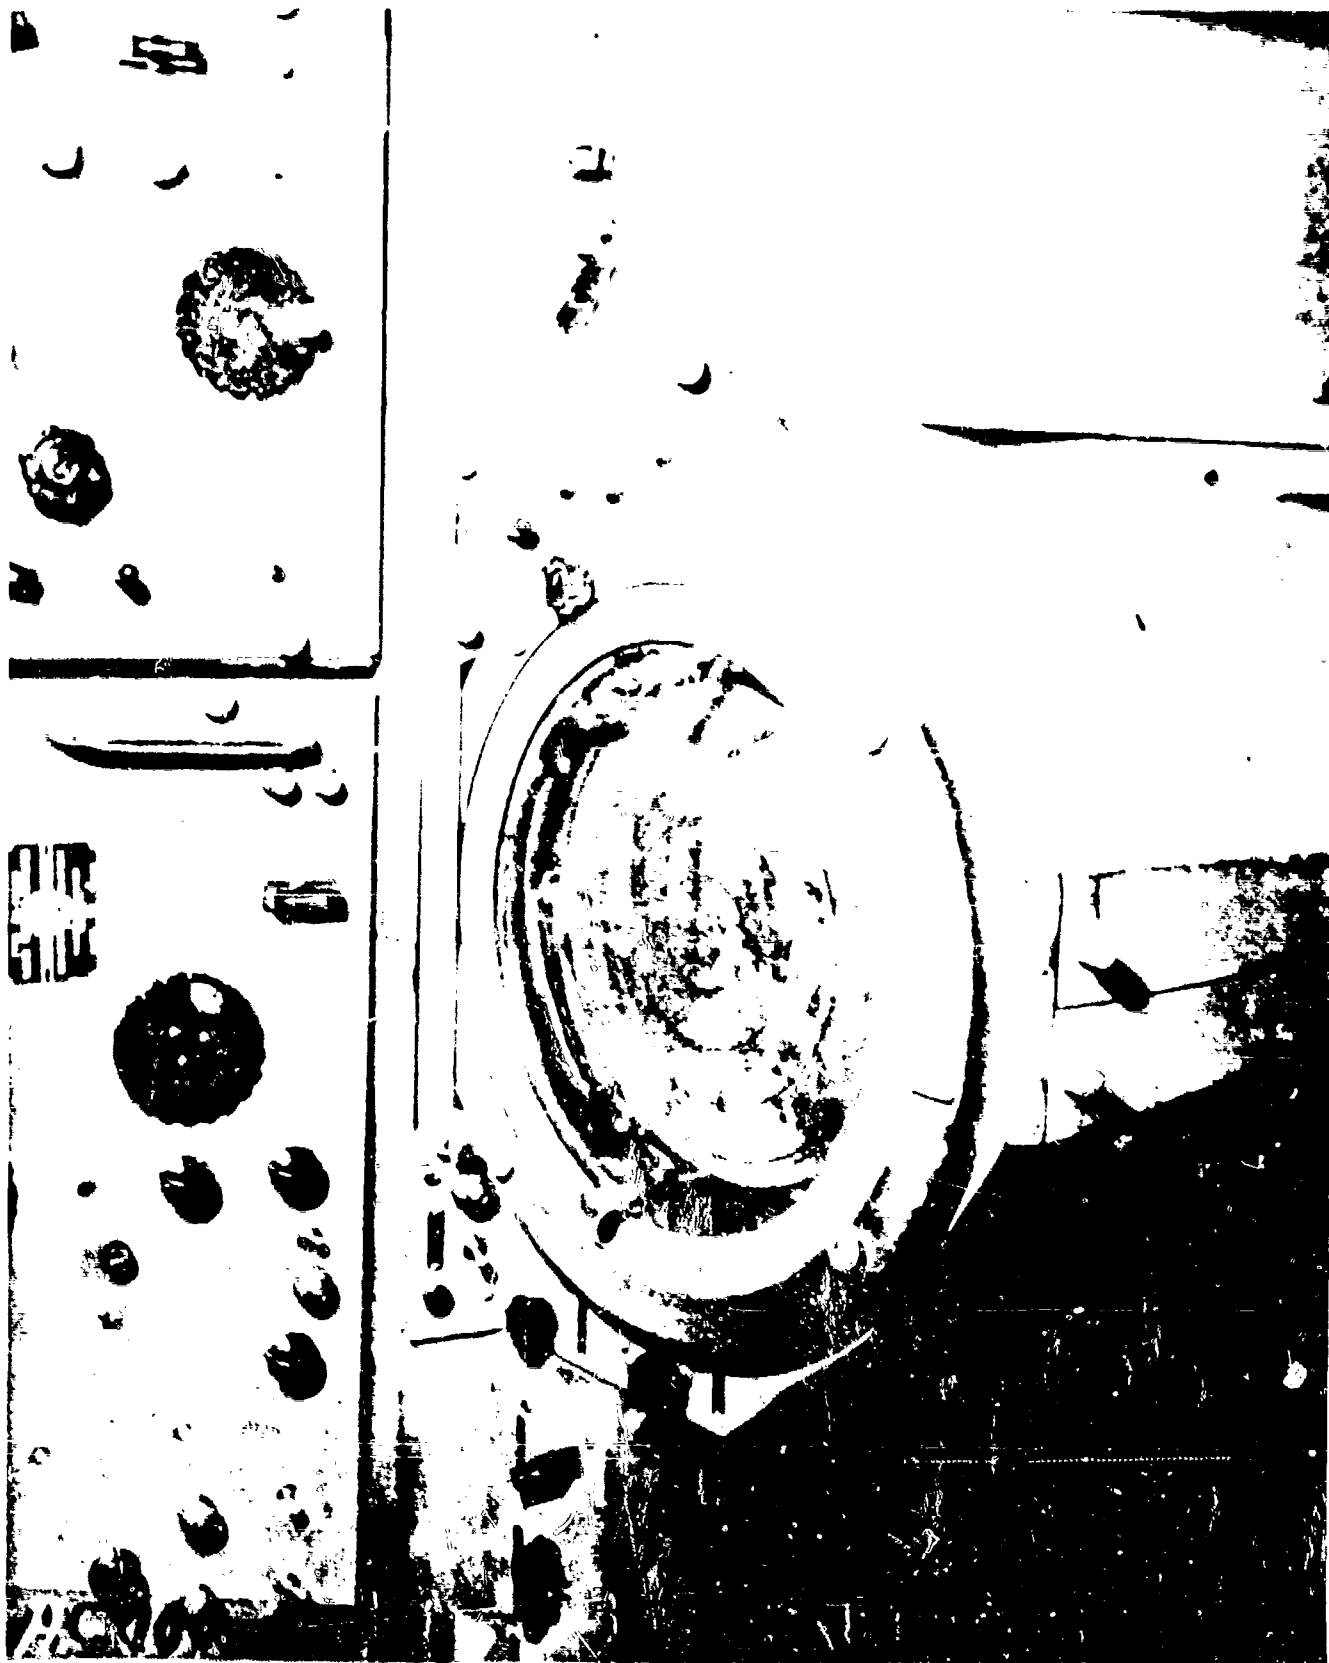
POST ABLE - SC-4 P.P.I. One of several cases where an SC PPI tube was broken at the neck because positioning screws were not properly tightened. The inrush of air through the neck of the tube blew the fluorescent material off the screen.

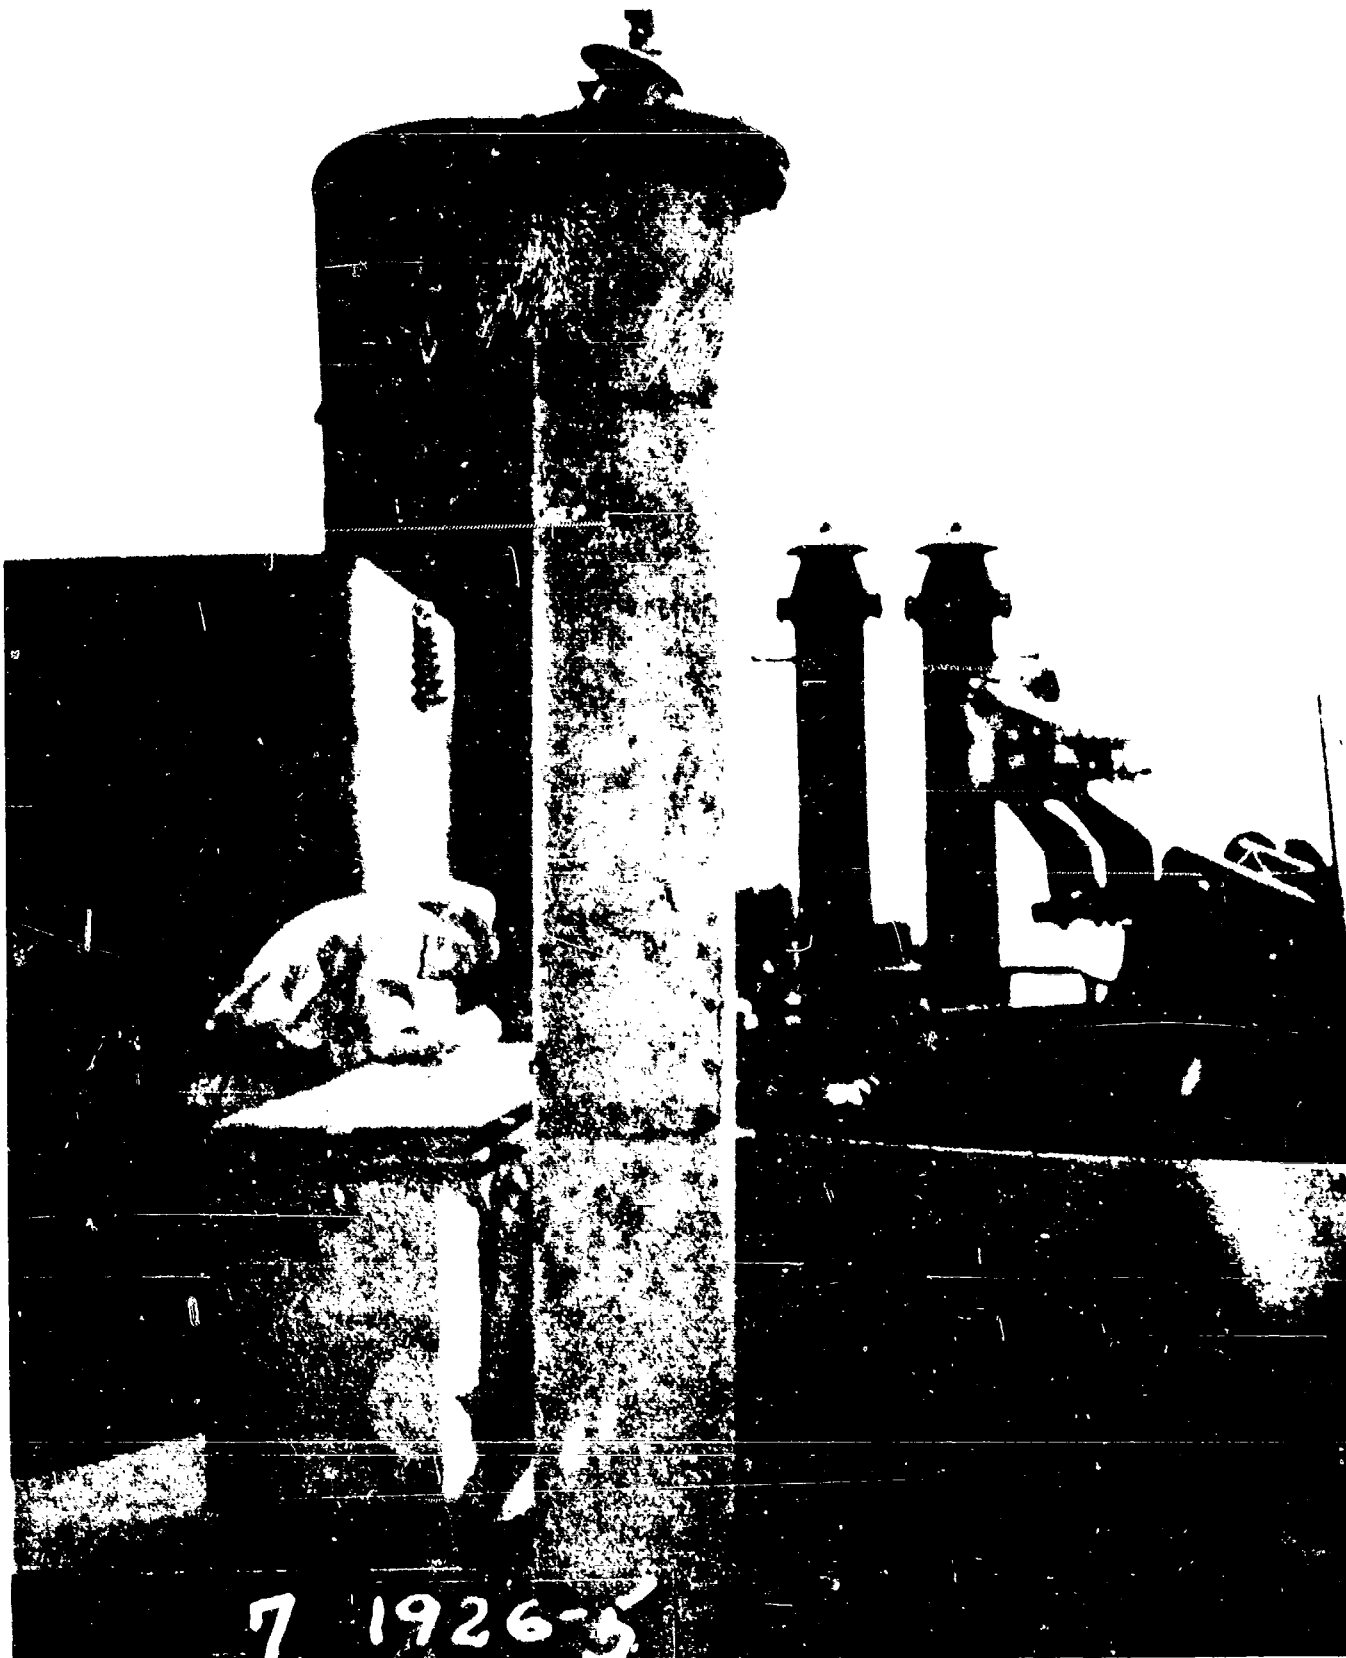
POST ABLE - ANTENNA TRUNK. Entering insulator was damaged and strain insulator broken by the blast.

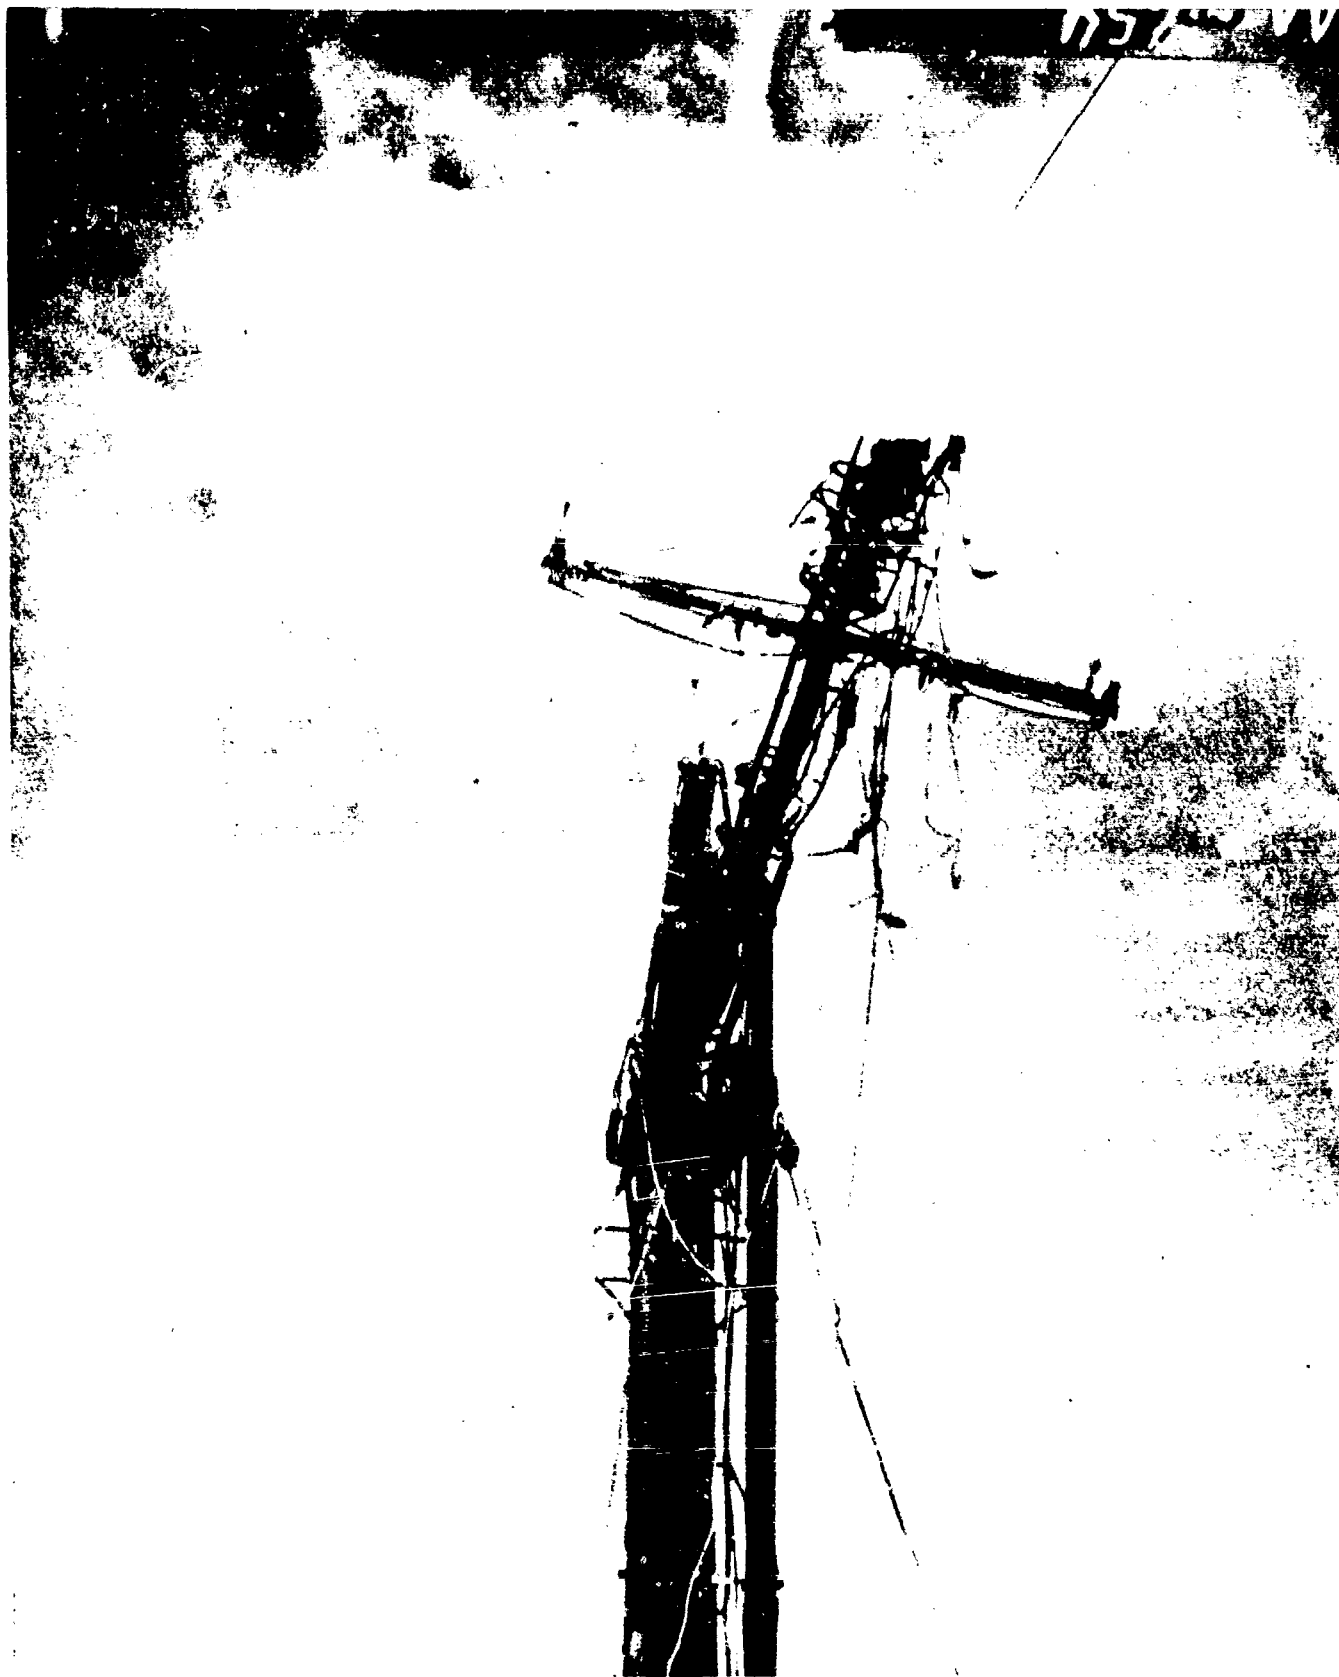
POST ABLE - FOREMAST. Top section blown over. Reflector was broken off of SG-1 antenna and waveguide collapsed.

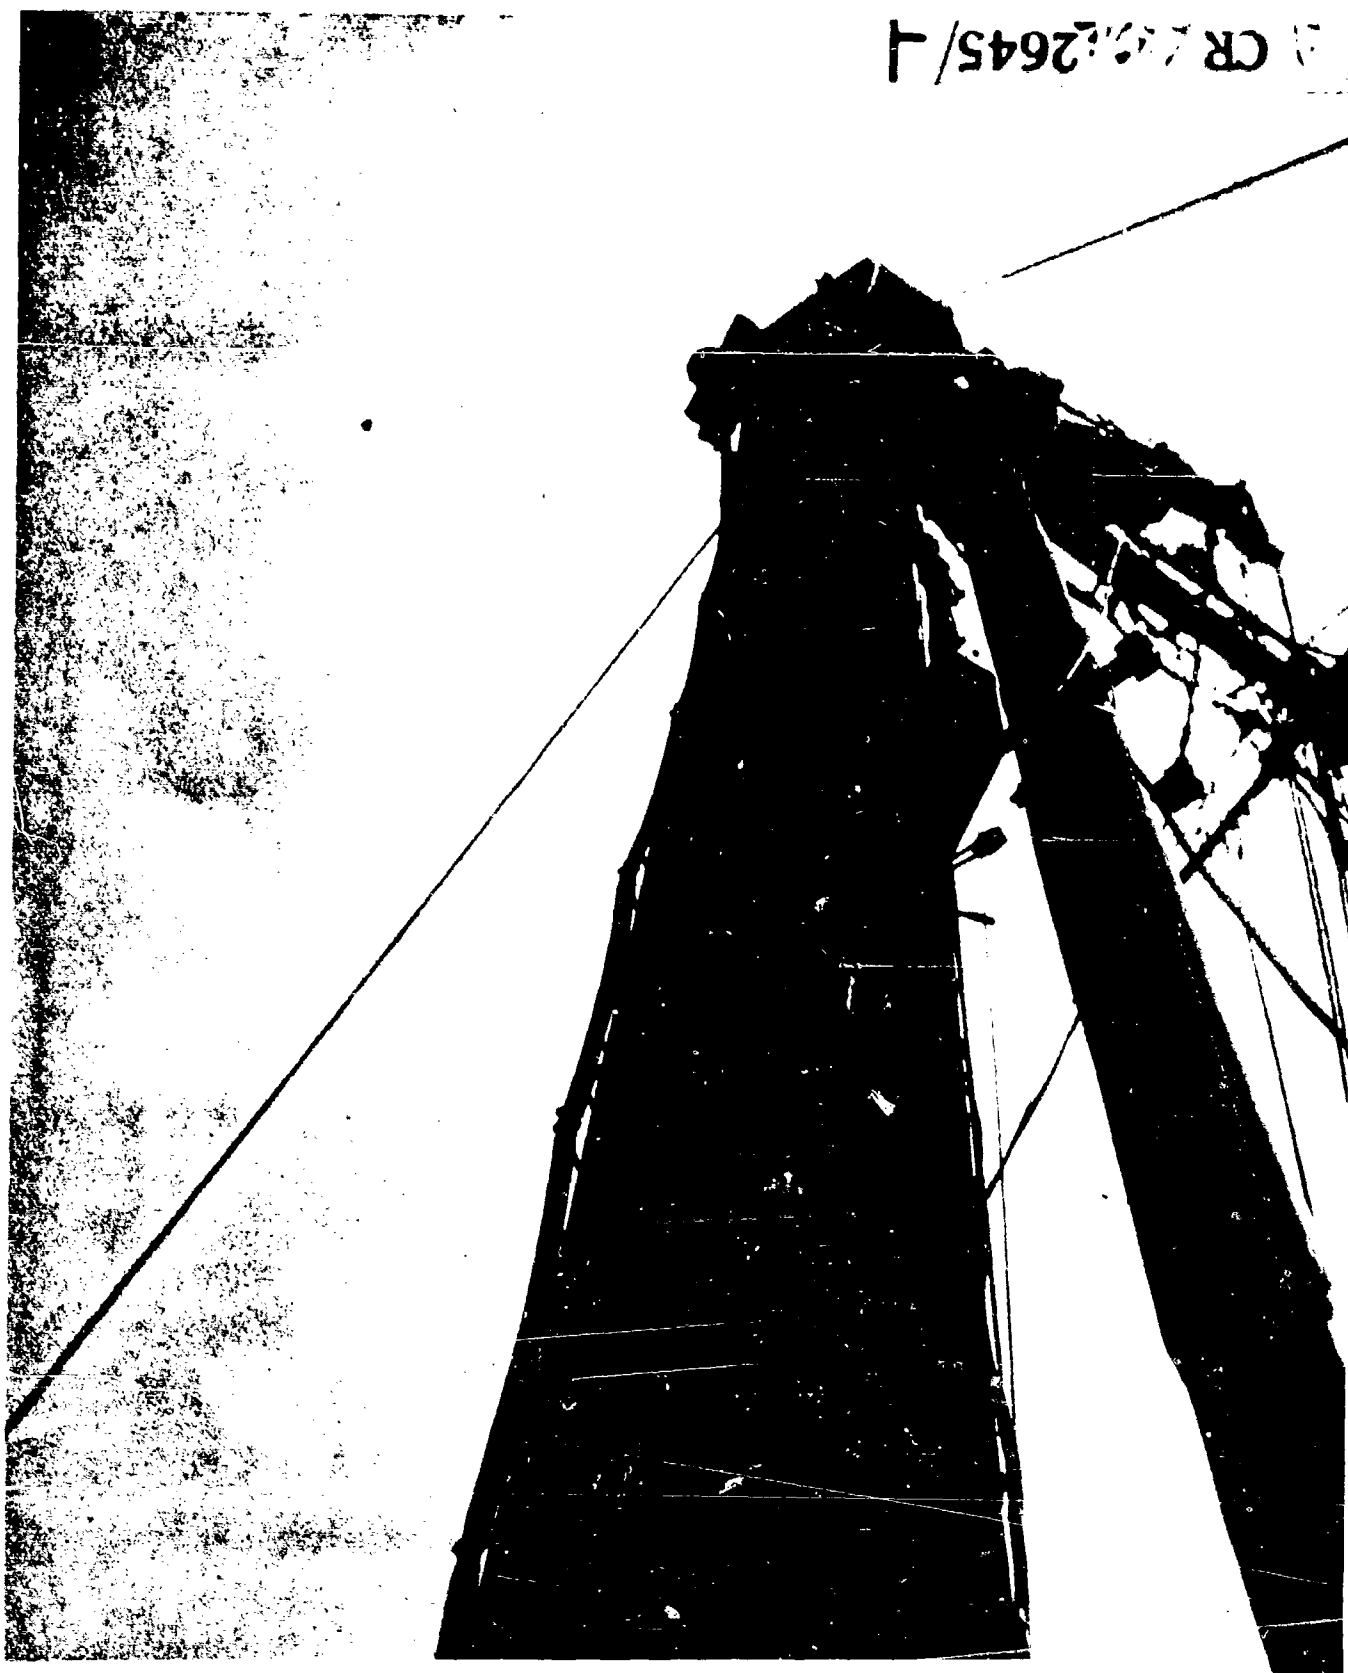
POST ABLE - FORECAST. Top section blown over. Note condition of waveguide at center of picture, where flange has separated from guide at soldered joint. Waveguide was flattened and next line twisted for full length of exposed run.

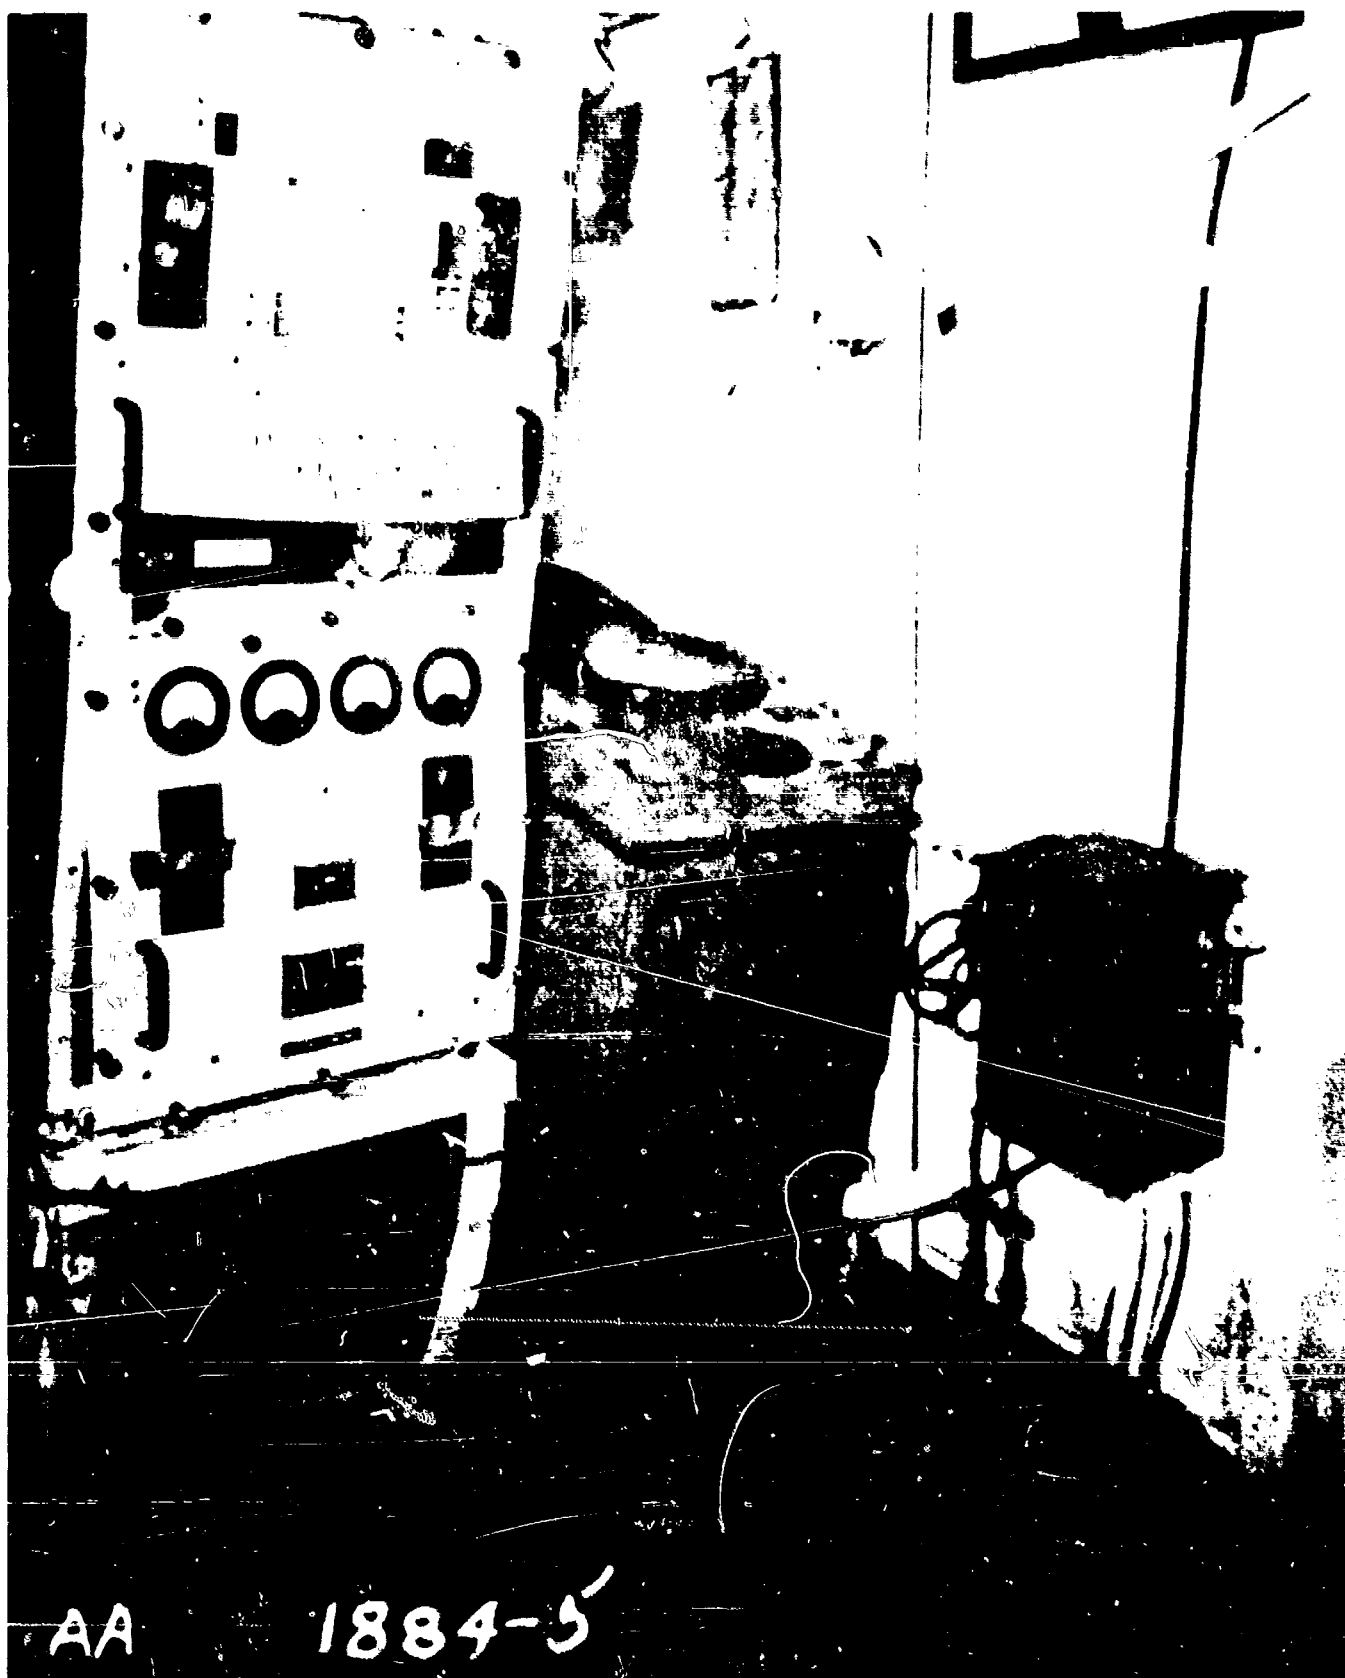
POST ABLE - PILOTHOUSE. Front view of NMC and VD-2. The welds parted on the VD-2 foundation, and the selector switch was torn from its mount. However, the VD-2 was still operable. The NMC was warped and had internal damage.

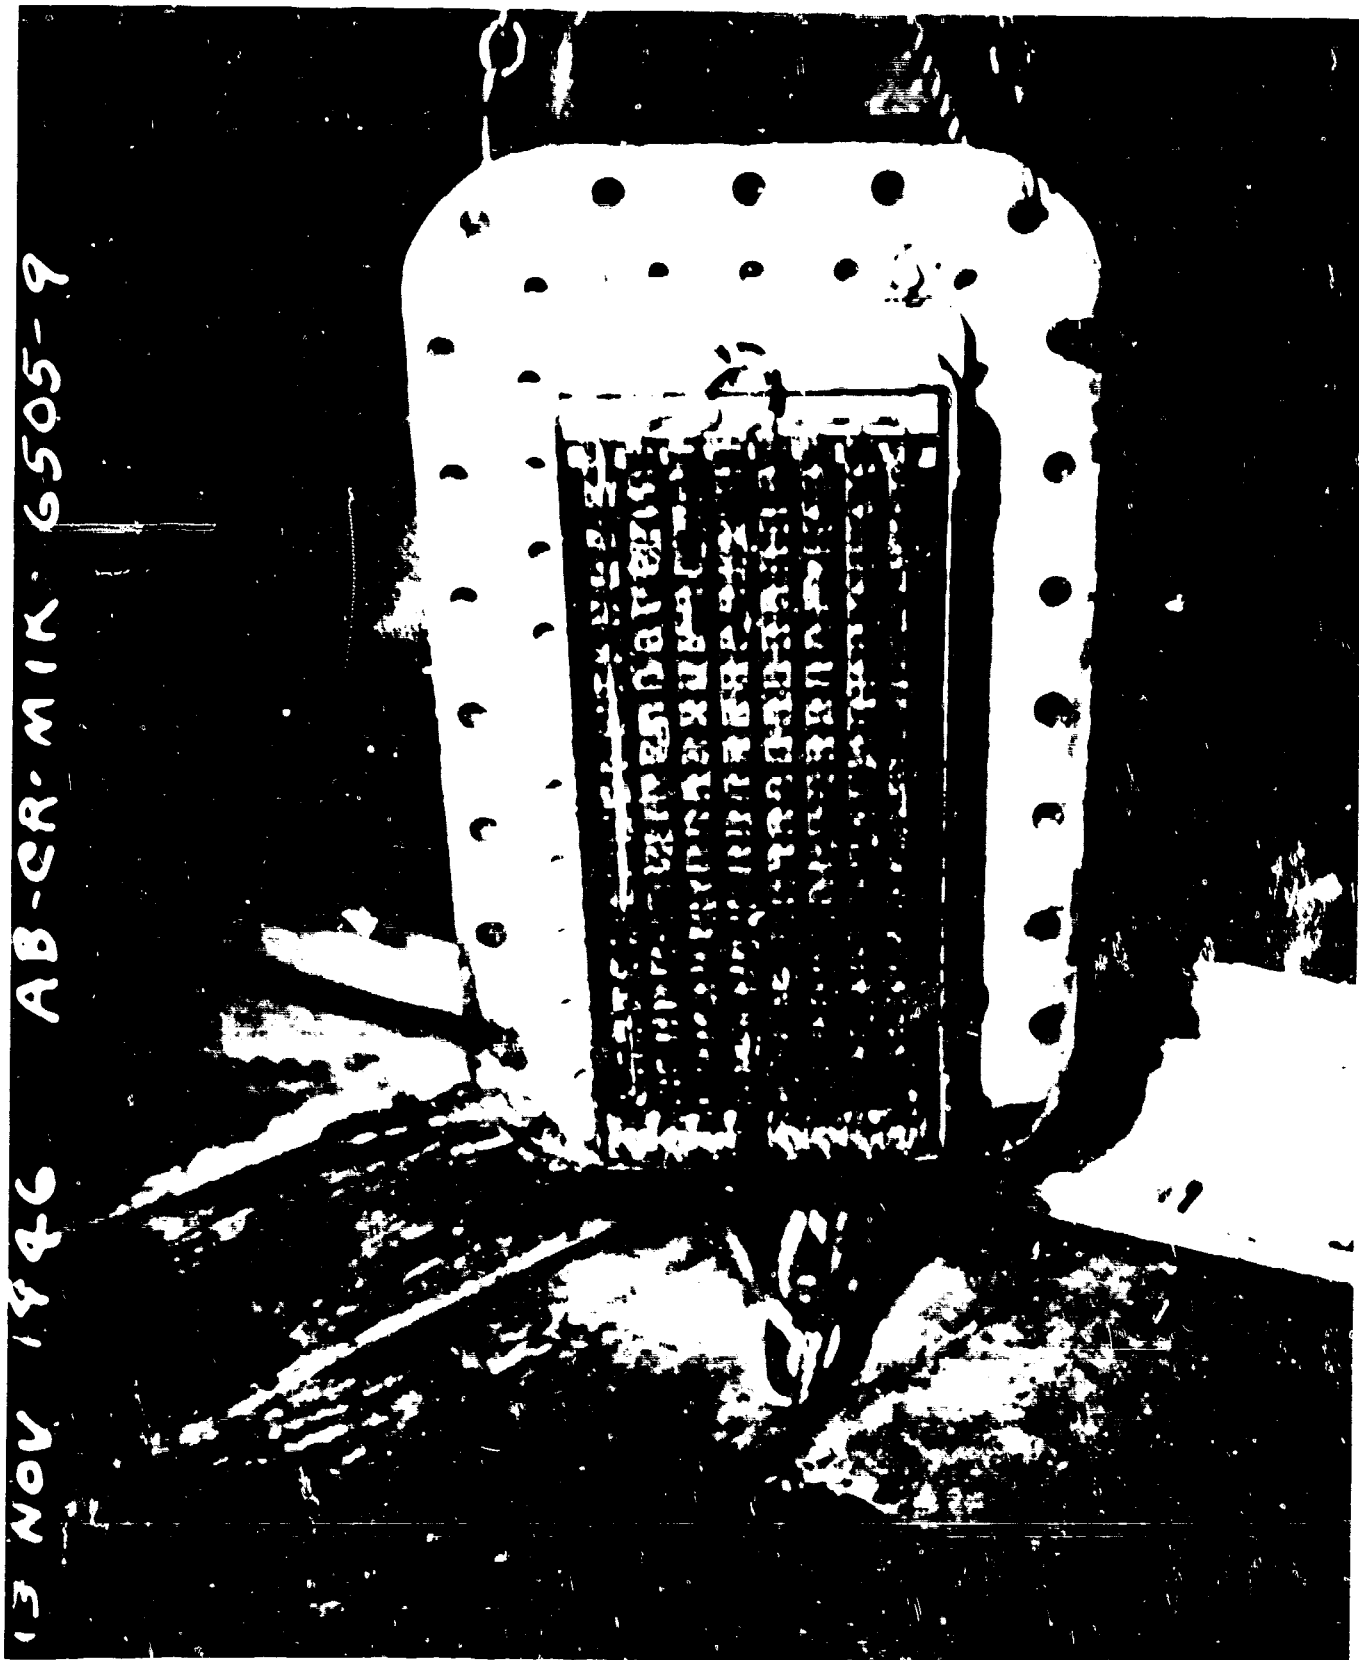
POST BAKER - NSA PROJECTIONS. Face view of cover plate and crystal assembly, showing broken and missing crystals.
